Improvement of Taphole Cleaning Equipment at İsdemir Blast Furnaces

İskenderun Iron & Steel Co. İskenderun/Hatay- Turkey

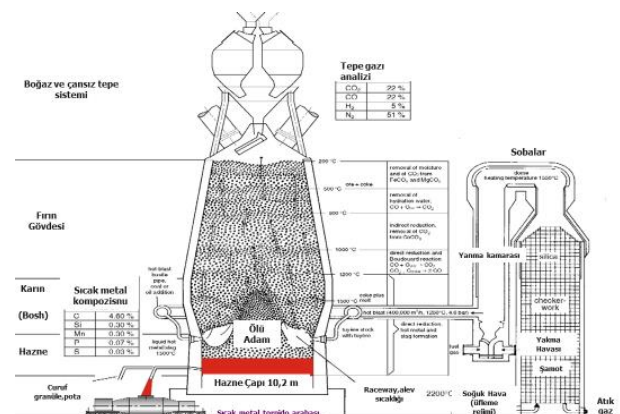
In each blast furnace of İSDEMİR there are 10-12 casting operations per day and total 30-36 castings are performed daily. Tap holes are checked after the end of casting process and employees checked whether there is a risk that may affect production. Figure 1 shows the general scheme of blast furnaces. in this figure, the tap holes in which the liquid pig iron is discharged from the blast furnace are also seen.

Figure 1. General scheme of blast furnace

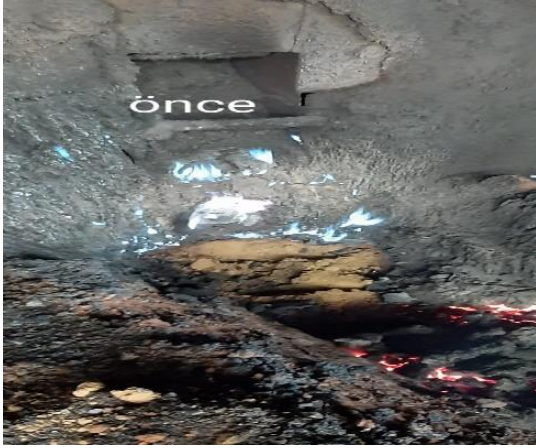
tap hole can not cleaned properly by cleaning equipment. As the cleaning process cannot be done properly, production losses due to tap hole occur. Scals may accumulate around the spill hole when cleaning is not performed properly and this situation shown in Figure 2. Scals accumulated around the tap hole leads to production losses.

Figure 2. Scals around the tap hole

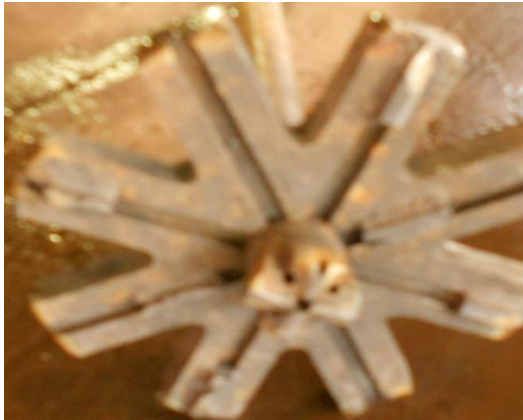
Old type cleaning equipment will be damaged in a short time and because of this problem, around of the

Figure 3. Old Type Cleaning Equipment

Instead of the rod-shaped cleaning bits used in the old type (Figure 3 old-style tip technical drawing), 8 WC drill bits (Figure 4) are used as consumables used in the furnaces in casting opening process. These drill bits are less susceptible to rupture and rapid wear problems with older drill bits. The problem of axial misalignment in the center of the cleaning equipment is also prevented from slipping out of the center by extending the length of the drill bit used in the center and inserting it into the tap hole. (Due to the misalignment in the center, the problem of not being able to close the casting is eliminated.)

equipment when mud is pressed with mudgun to close the casting hole, the amount of mud spreading around the tap hole is reduced. If the tap hole cannot be filled with mud, the liquid pig iron solidifies in the tap hole and this situation leads to the use of more than a drill bits for drilling the tap hole and leads to a short casting operation. With the improvement project, the problem of accumulation of liquid pig iron in the tap hole was prevented. This situation leads to a reduction in the costs of casting operations .As can be seen in Figure 8, the surface cleaning of the casting holes has been made better with the new design cleaning apparatus and the bits used in the old type apparatus (Figure 3) have been saved and thus savings have been achieved.

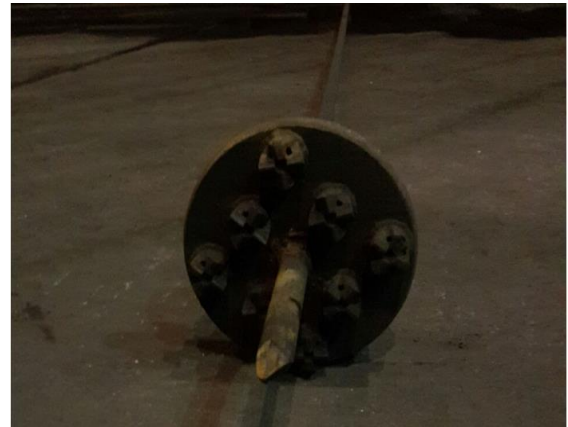
Figure 5: New Cleaning Equipment

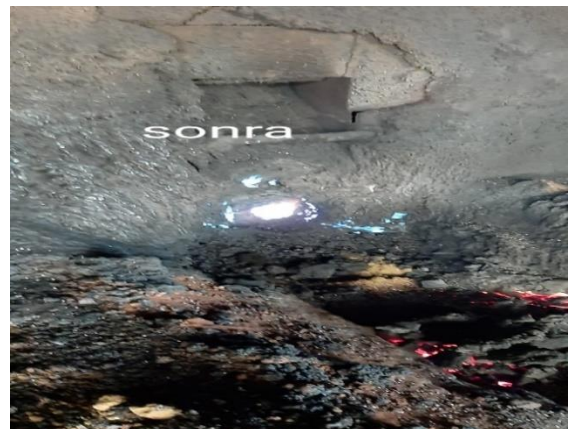
Figure 6. around of the tap hole cleaned by new cleaning equipment
